NWS Form E-5 (04-2006) (PRES. BY NWS Instruction	U.S. DEPARTMENT OF CONTROL OCEANIC AND ATMOSPHERIC ADMINITIONAL WEATHER NATIONAL WEATHER	STRATION San Angelo TY
MONTHLY REF	PORT OF HYDROLOGIC CONDITIONS	REPORT FOR: MONTH YEAR September 2012
NOA 1325	ologic Information Center, W/OS31 A's National Weather Service East West Highway r Spring, MD 20910-3283	SIGNATURE Jason Johnson DATE October 14, 2012

After the first week of September, several cold fronts pushed through west central Texas during the month. These cold fronts brought relief from the hot summertime temperatures and produced generous amounts of rain across portions of the San Angelo hydrologic service area (HSA).

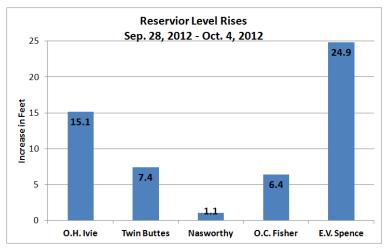
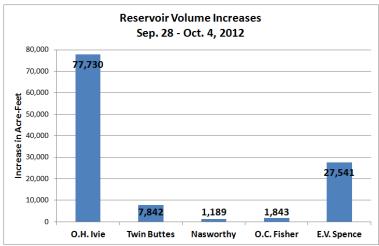
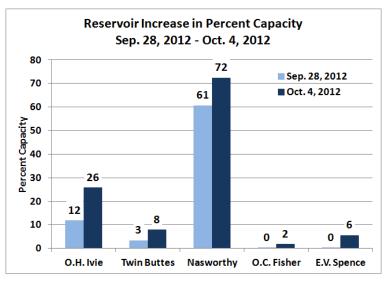
The widespread heavy rainfall was beneficial to area water supply reservoirs across the Concho Valley. The area has endured drought conditions since late 2010. Since very few rainfall events since late 2010 have generated runoff, this event was significant in relieving depleted water supply reservoirs. The following graphs depict the increases in area surface water supply reservoirs.

Reservoir	Conservation Capacity (Ac-Ft)	End of Month Capacity (Ac-Ft)	Percent of Capacity (%)
Fort Phantom Hill	70,030	36,280	52
Lake Stamford	51,570	16,190	31
Hubbard Creek Lake	317,800	116,740	37
Hords Creek Lake	8,640	1,490	17
Lake Brownwood	131,428	72,560	55
E.V. Spence	488,760	7,020	1
O.C. Fisher	119,200	2,030	2
O.H. Ivie	554,340	139,700	25
Twin Buttes	177,800	13,800	8

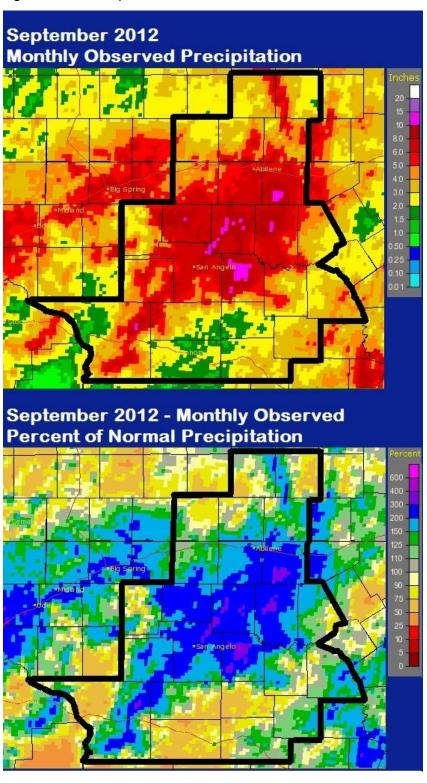
The total monthly precipitation estimate and percent of normal precipitation for September across the San Angelo HSA is depicted below.

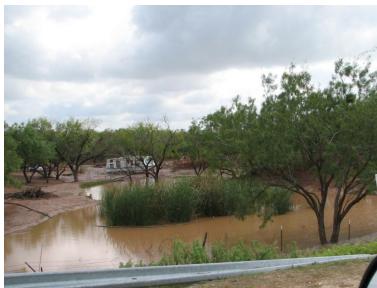
Right overbank of Colorado River near Ballinger, left photo is on 9/29, right photo is on 9/30.

September 27-29: A significant rainfall event unfolded late in the month as moisture from the Gulf of Mexico and eastern Pacific fueled several upper level disturbances that moved across the region from Mexico. A very moist airmass was created by combining Gulf moisture at the lower levels with middle and upper level moisture from the remnants of Hurricane Miriam from the eastern Pacific. Late on the 27th into early on the 28th, very heavy rain (three to five inches) occurred over parts of Callahan, Concho and McCulloch Counties. On Beals Creek, in Mitchell and Howard Counties, widespread rainfall amounts of 2.5 to 6 inches created an initial flood wave on the Colorado River. Another series of widespread heavy rain showers occurred late on the 28th into the early morning hours of the 29th. Much of the upper Colorado River Basin (upstream of O.H. Ivie Reservoir) received widespread three to six inches of rain. Isolated areas in Tom Green, Concho and Runnels Counties observed eight to ten inches of rain. Significant rises were observed along the Colorado River from above Silver to E.V. Spence Reservoir in Coke County, along the Colorado River in Runnels County to O.H. Ivie Reservoir and on the Concho River in eastern Tom Green County to O.H. Ivie Reservoir. The flood impacts reported from county officials and newspaper reports include damage to FM, County and private roadways, flooding of temporary hunting campsites along the creeks and rivers, damage to fences, and flooding of low lying areas that caused rural residents to be cut off from primary and secondary roads. Photos of the Colorado and Concho Rivers can be found at the end of this report.

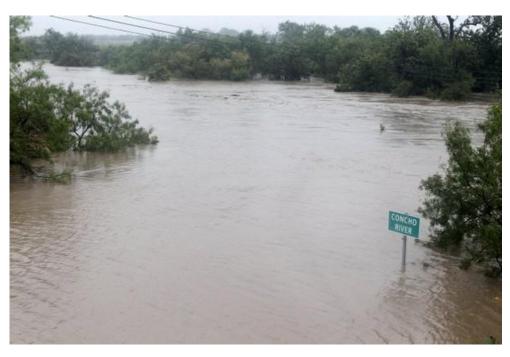
Concho River at FM Road 1692 in eastern Tom Green County upstream of Paint Rock.

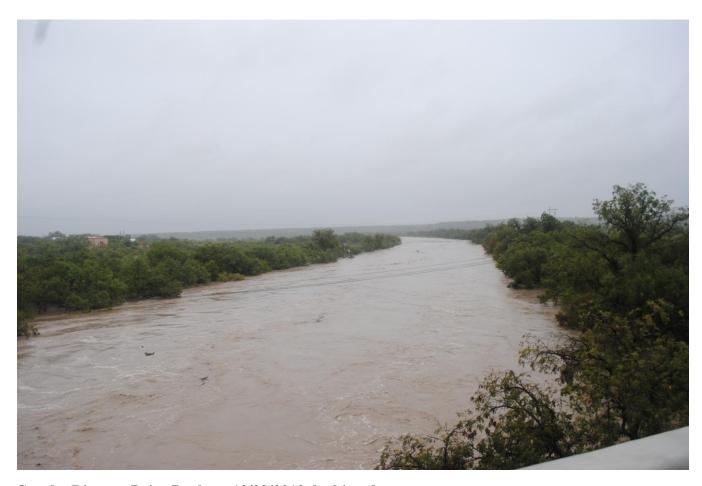
Concho River at Paint Rock on 10/29/2012, looking downstream.
